### X-333 Uranium Enrichment Process Building

# X-533A High Voltage Switchyard, X-533 Switch House, X-533C Test and Repair Shop, X-533D 0il House, X-533E & F Valve House, X-533 Gas Reclaiming Cart Garage, and X-533T-1 Trailer; collectively the X-533 Switchyard

## X-630-1 Recirculating Water Pump House, X-630-2A Cooling Tower, X-630-2B Cooling Tower, and X-630-3 Acid Handling Station

## X-633-1 Recirculating Cooling Water Pump House, X-633-2A Cooling Tower, X-633-2B Cooling Tower, X-633-2C Cooling Tower and X-633-2D Cooling Tower

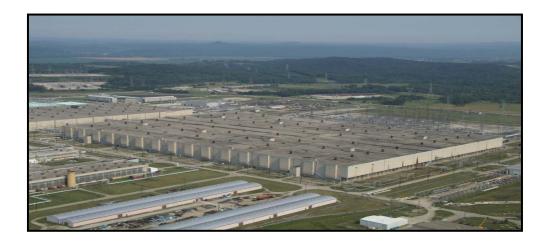
**Description:** X-333 is a two story steel frame building constructed in 1955. The power, utilities and controls are on the first floor and the 640 "000" size cell stages are on the second floor.

- Cat 2 Nuclear building
- There are 65 acres of floor space
- Large quantities of Asbestos Containing Material are present, including exterior siding, cell housing siding and pipe insulation
- Flat composite gravel-coated asphalt roof
- Cells have been treated to less than Always Safe Mass
- Fire protection is being converted to a dry pipe system
- Railroad spurs are located on East and West sides
- Area heat is provided by electricity. Steam heat is still utilized for various systems.
- Power is provided from the X-533 switchyard but soon will be from the X-530 switchyard.
- 2nd floor and about 30% of the 1st floor are contamination control zones

- Lead Acid Batteries
- Aluminum Oxide, Sulfuric Acid, Nitric Acid
- Fuels: Gasoline, Diesel, and Kerosene
- Anti- freeze
- Concrete floors have PCB contamination due to leaks from transformers and HVAC duct gaskets and chromium contamination from recirculating cooling water leaks.

- Large quantities of fluorescent light tubes and HVAC control switches containing mercury are present
- PCBs are present in over 80 transformers and more than 6000 static capacitors.

- 125,000 gal of PCB transformer oil
- 59,000 gal of process lube oil in 16 tanks on 1st floor
- Residual R-114 (52,000 lbs) in cell cooling system, cold recovery system and air conditioners

- Classified materials include Converters, Compressors and Compressor seals
- There are 11 high bay cranes used to lift the process equipment (e.g., converters which are the largest weighing 33 tons) the cranes are in place, the Department makes no claims to certification status or operability

- A small amount of transuranics is present
- The building has presence of Tc-99

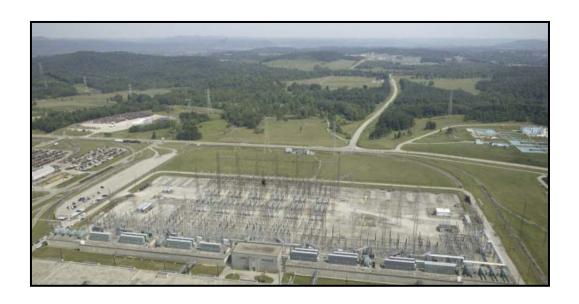
**<u>Description:</u>** The X-533 Switchyard receives power from the grid at 345 kv and steps it down to 13.8 kv for distribution to the X-333 Process Building and area auxiliaries.

The X-533A is a fenced, graveled, 770,000 SF yard housing 16 transformers and 18 associated gas-filled circuit breakers for controlling power. A sulfur hexafluoride (SF<sub>6</sub>) gas cart and equipment for filling the gas circuit breakers is stored in the yard.

The X-533B is the 150,000 SF two-story control room flanked by 2 switch houses constructed of concrete and steel with transite siding. They house synchronous condensers, auxiliary transformers, air blast circuit breakers, air compressors to operate breakers, HVAC equipment, power cables, and controls.

- Extremely low levels of PCBs are present in select transformers
- Electrical cables are lead-covered
- Lead-based paint
- Battery acid
- Mineral oils potentially contaminated with PCBs
- Asbestos is present on pipe insulation and transite exterior siding
- Mercury in switches and fluorescent light tubes
- Freon in HVAC chillers
- SF<sub>6</sub> gas
- PCBs are present in HVAC duct gaskets and light ballast
- PCBs are present in soils from previous transformer leaks
- VOCs in the soil from historic cleaning with carbon tetrachloride and TCA
- Contamination control zones around ventilation ducts on the ground floor of both switch houses
- Lead Acid Batteries
- Compressed Gas Cylinders
- Halon fire protection system

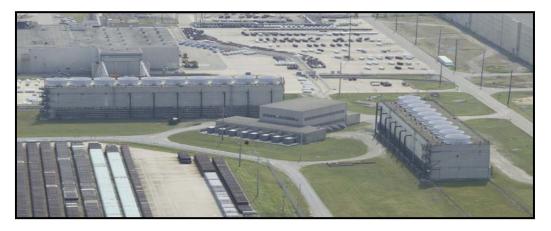
**Description:** The X-630-1 is a 10,200 SF reinforced concrete building with transite siding. It houses vertical water pumps to circulate RCW from X-630-1 to the X-330 Process Building and return to the two towers.

The X-630-2A and X-630-2B are each a 10 cell wood cooling tower over a basin that extends under the pump house. The 22–ft diameter fans are driven with electric motors, but are not in service.

- Towers have Asbestos Containing Material in siding and pipe insulation
- PCBs in five pole-mounted transformers and fluorescent light fixture ballast
- Sulfuric acid storage tank at X-630-1
- Lead base paint
- Chromium in the wood and soils from historic use of chromate water until 1991
- Mercury in fluorescent light tubes
- Lead Acid Batteries
- Corrosion/deposition prevention chemicals stored in above ground tanks

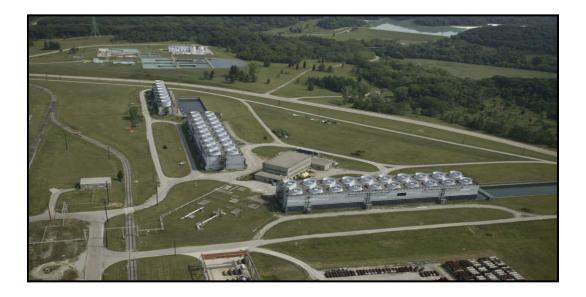
**Description:** The X-633-1 is an 11,000 SF reinforced concrete building with transite siding. It houses vertical pumps to circulate RCW from the cooling towers to the X-333 Process Building and return to the towers. There is a row of mineral oil transformers along the northeast outside wall.

The X-633-2A, B, C, & D are wood-framed, transite-siding cooling towers over concrete basins that connect with the basin under the X-633-1. The A and B towers are original, have 20 cells with 20 ft diameter fans and cover 24,000 SF each. The C & D towers were added in the 1970s, have 8 to 10 cells each with 24-ft diameter fans and cover 15,000 and 18,000 sf. The fill in the cells was replaced in the 1990s with a special high surface area material. The first high performance fill material was rubber-coated corrugated asbestos.

- The cooling towers have visible structural damage
- Towers have Asbestos Containing Material in siding and pipe insulation
- PCBs In transformers and fluorescent light fixture ballast
- Sulfuric acid and corrosion/deposition prevention chemicals stored in above ground storage tanks

- Lead base paint
- Chromium in the wood and soils from historic chromate water treatment
- Septic tank and leach bed
- Mercury in fluorescent light tubes
- Lead –Acid Batteries

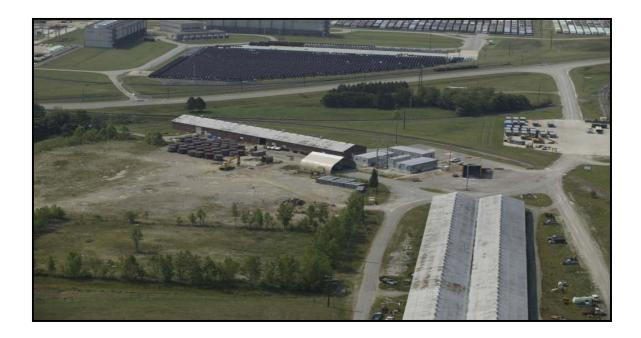
## X-747 Storage Yard

**<u>Description:</u>** X-747 storage yard includes nine designated uncovered storage areas. The X-747 is a clean scrap yard used for storage of used, surplus equipment, and scrap.

- Soils are assumed to be contaminated with oils, fuels, and unspecified chemicals
- Freon may be present in surplus refrigeration and air conditioners
- Lead-based paints are assumed to be on much surplus equipment
- Asbestos Containing Material may be present inside scrap instrument cabinets and/or pipe manifolds
- Much of the surplus equipment is unlabeled

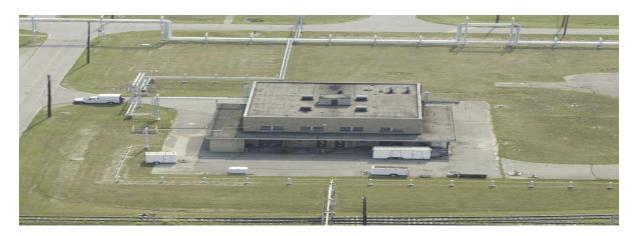
### X-760 Chemical Treatment Facility

**<u>Description:</u>** X-760 is an 8,000 SF two-story masonry building with north and south high bays housing chemical equipment. Restrooms, lockers, offices, and electrical equipment room are on the east side.

A neutralization pit is located on the north side. Currently, the facility is used for storage of equipment from pilot plant experiments. Historically, it was used to conduct studies of methods to recover uranium from solutions, to study UF<sub>6</sub> releases in an environmental chamber (North High Bay), to treat PCBs with sodium, and to conduct a wide variety of mechanical as well as chemical experiments.

- Condition of outside side stair and ladder conditions unknown
- Areas of the high bays are posted Contamination Control Zones
- A californium source for waste measurement "shuffler" was stored in the north storage room that may still be present
- Residues of many previously used chemicals are present
- Concrete floors are contaminated from a Variety of chemicals including but not limited to sodium, uranium, PCBs solvents, acetone, ethanol, paints, lacquers, sodium fluoride, contaminated oil, epoxies, PVC pipe cleaner and glue, chromium, and VOCs
- Mercury in fluorescent light tubes
- PCBs in fluorescent light fixture ballast
- Refrigerant in air conditioners
- Compressed gas cylinders
